**DEPARTMENT OF TRANSPORTATION**

Contract #: 04-0120F4Cty: SF/ALA Rte: 80 PM: 13.2/13.9File #: 69.28**WELDING INSPECTION REPORT****Resident Engineer:**Pursell, Gary**Address:** 333 Burma Road**City:** Oakland, CA 94607**Report No:** WIR-010044**Date Inspected:** 07-Nov-2009**Project Name:** SAS Superstructure**OSM Arrival Time:** 1900**Prime Contractor:** American Bridge/Fluor Enterprises, a JV**OSM Departure Time:** 700**Contractor:** Zhenhua Port Machinery Company, Ltd (ZPMC), Changxing Island **Location:** Shanghai, China

## WELDING INSPECTION REPORT

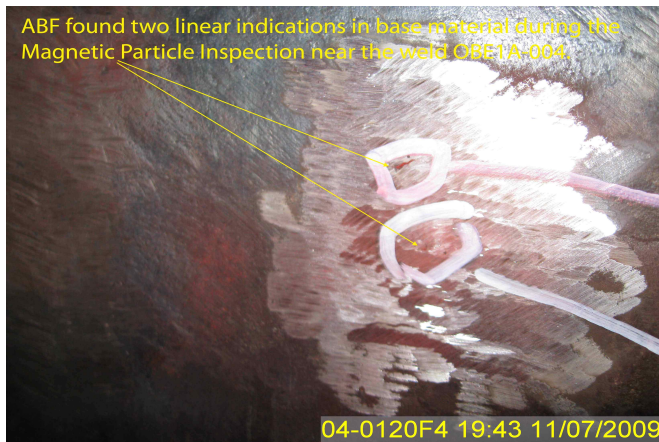
Magnetic Particle Testing (MT) performed on repair areas of weld OBE1A-004, OBE1A-002 and OBE1A-009. During the Magnetic Particle Inspection This QA observed ABF Inspector found two linear indications which is in base material approximately 70mm away from the weld OBE1A-004 towards OBG segment 1AE. The 'Y' location measured approximately 7780mm. The length of indication measured approximately 5mm. for additional information see the attached photo.
